## F. AK-WA SHIPBUILDING EPA Region 10 Deemed Releasable 1/20/2021

## : 1). INTRODUCTION

## a) Site Description and History

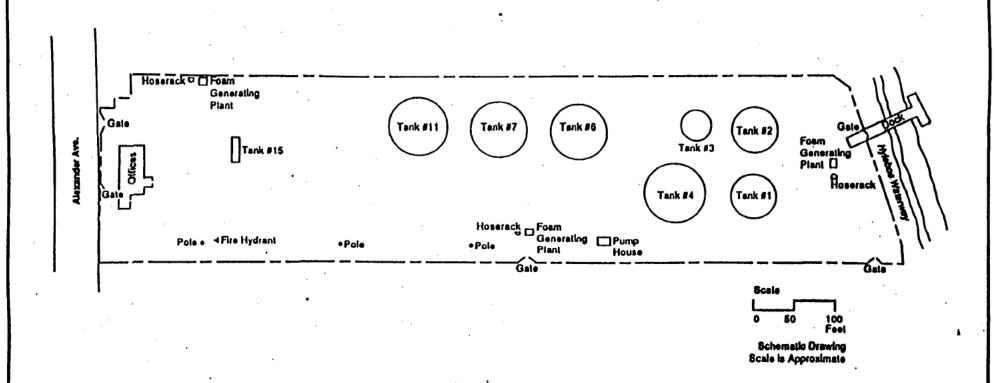
# Attachment 1b General Layout of AF POL Retail Distribution Station May, 1958, During DOD Useage.

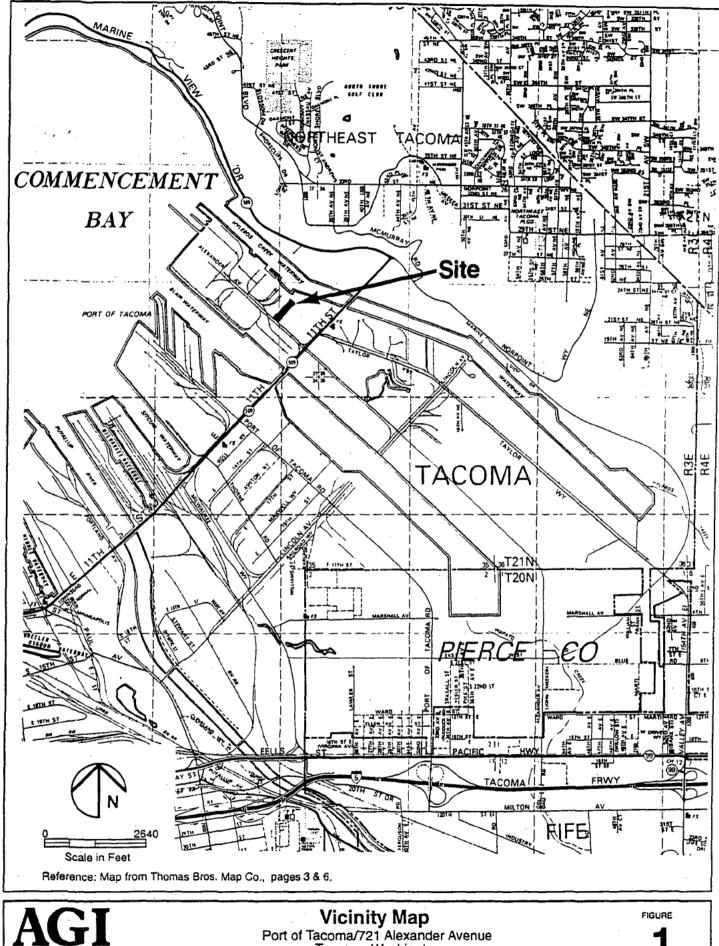
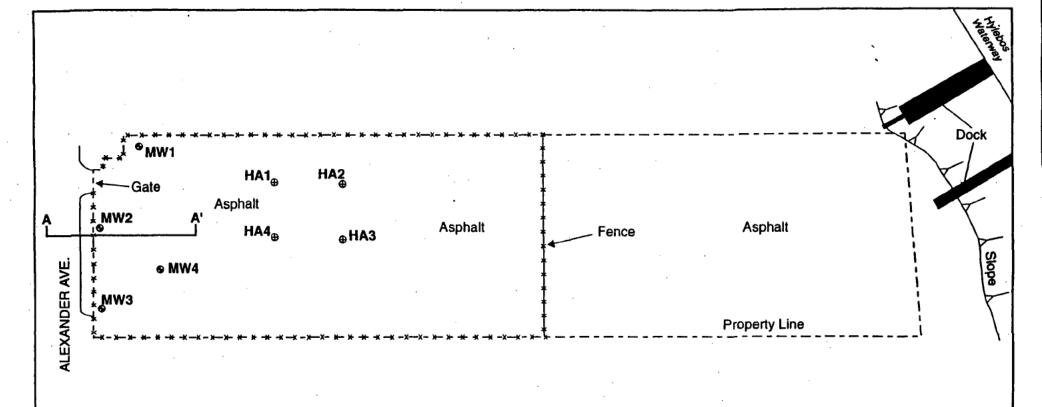
Reference: Port of Tacoma drawing No. EP-3833-12 titled: "Demolition of Tank Farm at 7211/2 AlexanderAvenue", May 17, 1983.

- 1							
١	ACT		Site Plan				
	TECHNOLOGIES		Port of Tacoma/721 Alexander Avenue Tacoma, Washington				2
- 1	<u>recinioeooles</u>	PROJECT NO.	DRAWN -	DATE -	APPROVED -	REVISED -	DATE -
١	siteplan.cdr	14,809.004	DFF	23 Jul 95

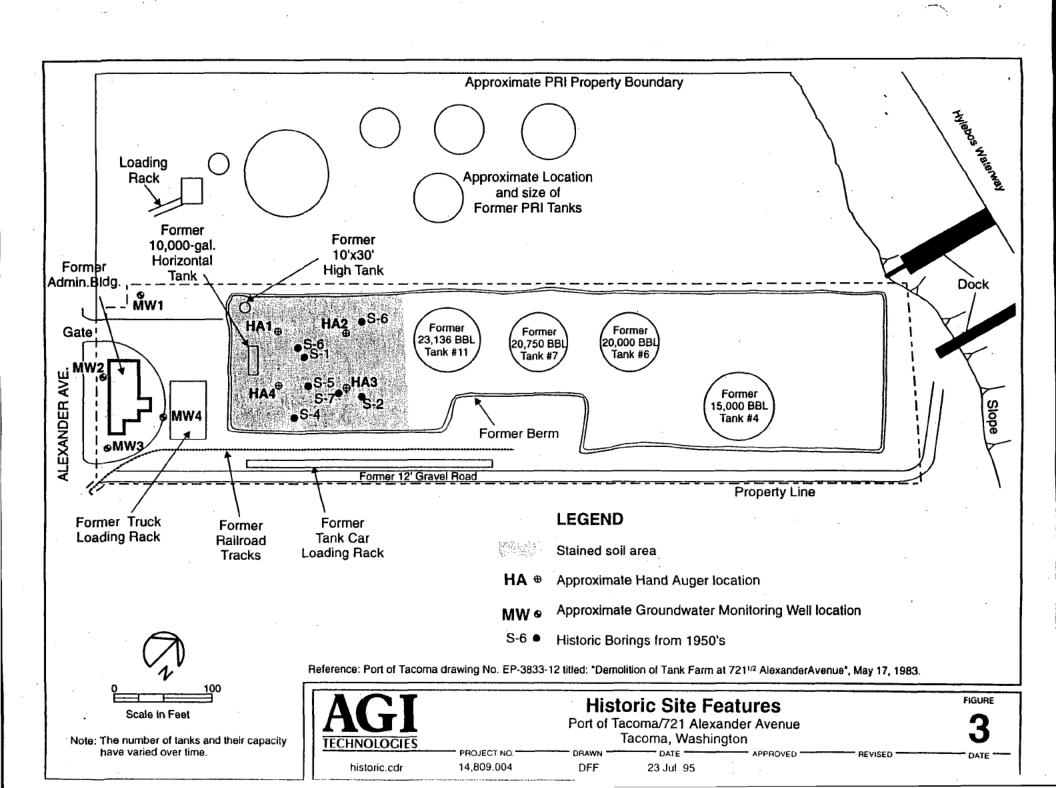
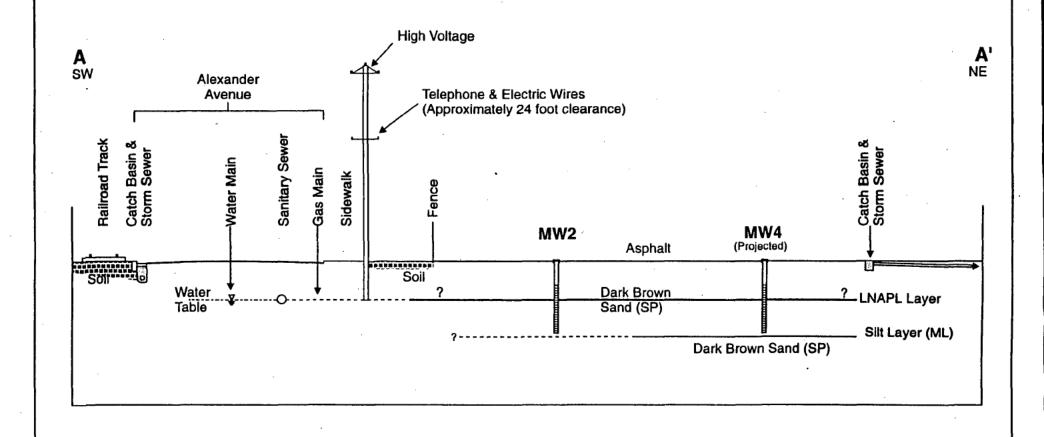
O 20
Horizontal & Vertical
Scale in Feet

No Vertical Exaggeration

Note: LNAPL = Light non-aqueous phase liquid

Ground water is present in saturated sands at 6 to 7 feet below ground surface under unconfined, water table conditions. LNAPL is floating on the water table at this depth, which is close to the invert depth of the sanitary sewer beneath Alexander Avenue. Ground water in the shallow saturated sands apparently flows from the PRI site toward the Port site and may flow from the Port site toward the sanitary sewer.
